# OBSERVER

## New Zealand Rotary Revisits Tongoa with Amazing Results

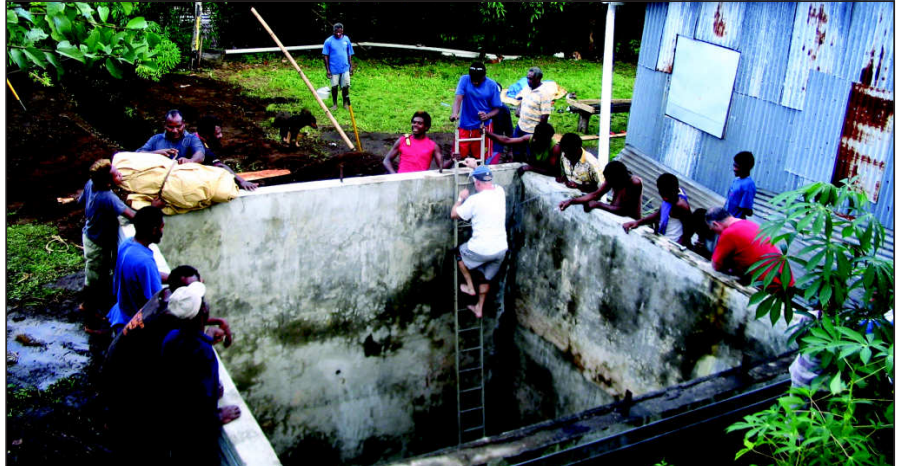
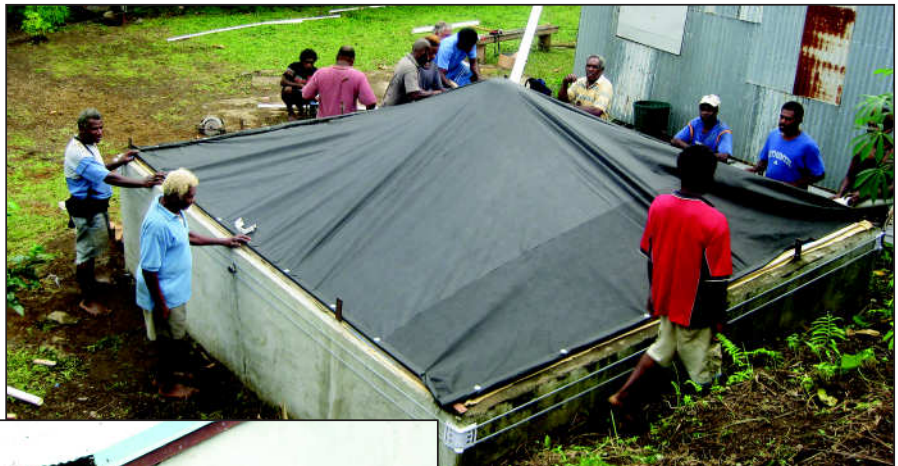
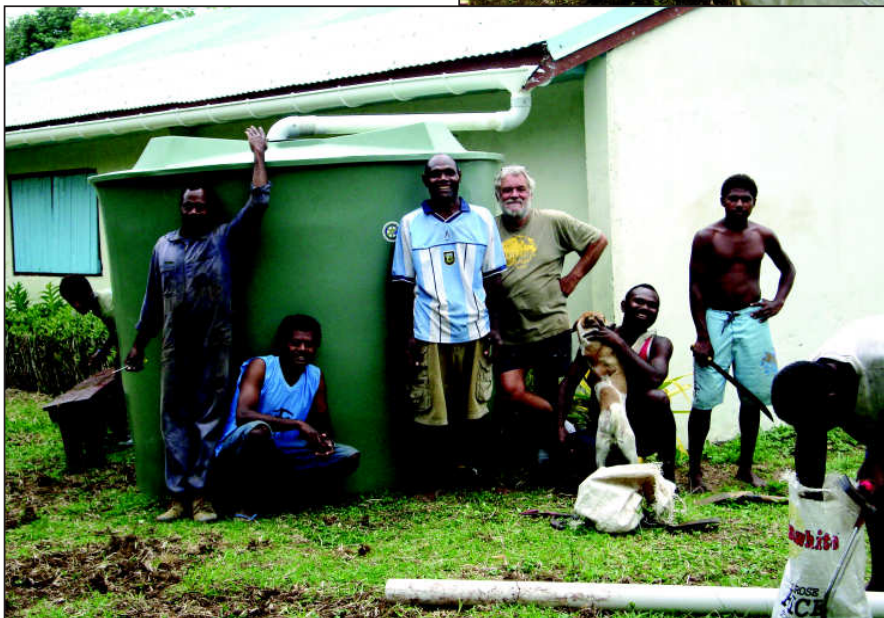
Although the Vanuatu Disaster relief agencies have supplied several polytanks to affected areas on the island Bongabonga Village had lost the use of a huge 64000 litre concrete tank which served over 100 people. The village was keen to see the tank repaired but despite all efforts to patch the cracks caused by the earthquake, the tank just wouldn't hold water. This was conveyed to the Rotary group in New Zealand who devised a scheme to permanently reinstate the tank.

The villagers immediately cleaned out 15 years of debris, smoothed any rough edges of concrete, installed the strapping around the tank using specially designed tension clamps and then fitted the liner – all in the first 4 hours of arrival.

The system worked brilliantly and overnight rain immediately began filling the tank.

The Rotary team had always been concerned about keeping insects, especially mosquitoes, out of these water tanks and a simple horticultural shade cloth cover was provided as a cover rather than the usual sheets of corrugated iron. The villagers have been urged to construct a simple thatched cover over this to provide shade and protect the fabric from sunlight.

Also, as a trial, a new type of plastic hand pump was provided to avoid the regular opening and closing of the cover and damage to the liner by buckets and lifting sticks.

This also was a success and the pump was quite capable of lifting water even up to 10 metres in depth. The refurbished tank is equivalent to 10 polytanks!
